Troubleshooting Common LC/MS Contamination

Chemical contamination is one of the more common problems with LC/MS. Try this troubleshooting path.

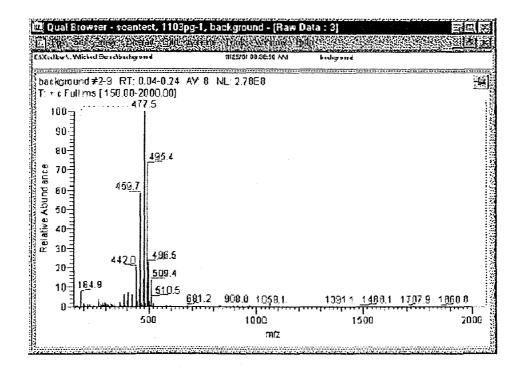
A long troubleshoot for a source of contamination in Nanospray ended when the user replaced: 97044-60290 HV Emitter Nanospray ay \$141 (the nanospray micro-Tee)

The spectrum was: 442.0, 459.7, 477.5, and 495.4 (see picture)

The emitter/Tee assembly had obviously become contaminated. This piece could be hard to clean as the electrode side of the Tee cannot be taken apart and assembled again correctly.
